Evaluation of medical X-ray machines in Paraíba state radiology centers between 2008 and 2009*

Mendes ACR, Ramos CL, Abreu DWM. Evaluation of medical X-ray machines in Paraíba state radiology centers between 2008 and 2009. Radiol Bras. 2011 Jul/Ago;44(4):244-248.

* Study developed at Agência Estadual de Vigilância Sanitária da Paraíba (Agevisa-PB), João Pessoa, PB, Brazil.

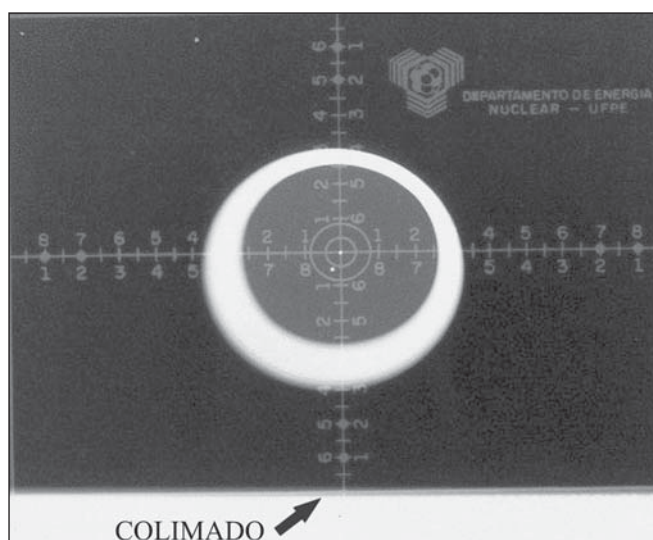
The congruence between the light and radiation fields was evaluated for analysis and interpretation of the images of the collimator test. The largest distance between the borders of the light field and those of the radiation field was measured. The greater the congruence between the light and the radiation fields, the better is the alignment. The difference between the borders of the radiation field and the borders of the light field must not be greater than 2% of the focus-film distance that is ± 2 cm away from the line corresponding to the device's rectangle^(9,11). The images generated on this test are represented on Figures 1 and 2.

Figure 1. Collimation system accuracy test. Image demonstrating compliant fields congruence.

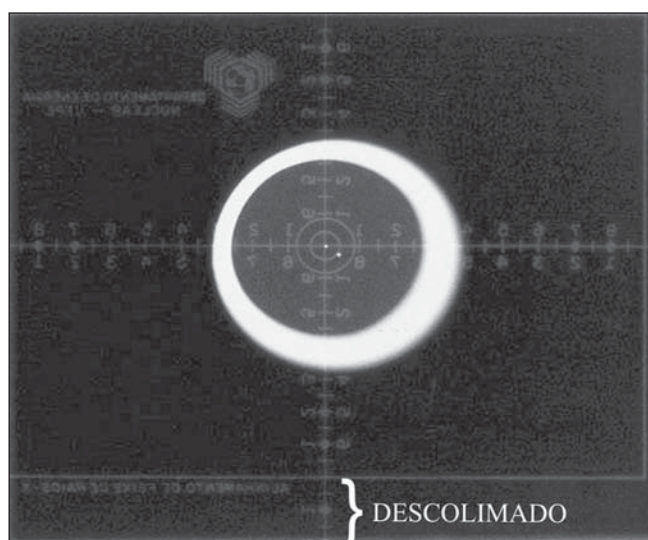
Figure 2. Collimation system accuracy test. Image demonstrating non compliant fields congruence.

After the evaluation of the tests results, in those cases in which the X-ray apparatuses were not in compliance with the standards, the institutions to which they belonged were notified and deadlines were established for corrective maintenance, after which the inspection team would perform new tests in the same apparatuses to check on the adjustments made.

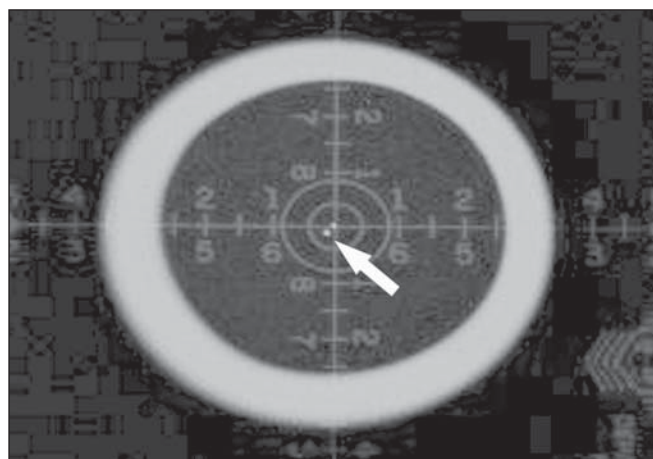
location of the image of the sphere on the top of the cylinder was verified. If the image of the upper sphere was within the first circle, the inclination corresponded to $< 1.5^\circ$. In those cases where the image of the upper sphere was located between the first and the second circles, the inclination was $< 3^\circ$ ⁽¹¹⁾. Whenever the image of the upper sphere intercepted the second circle, the perpendicularity of the central ray must be corrected⁽⁸⁾. Figures 3 and 4 represent the images of the X-ray beam central axis alignment test.

Figure 3. Central ray perpendicularity test. Image demonstrating the compliant incidence of the X-ray beam central ray.

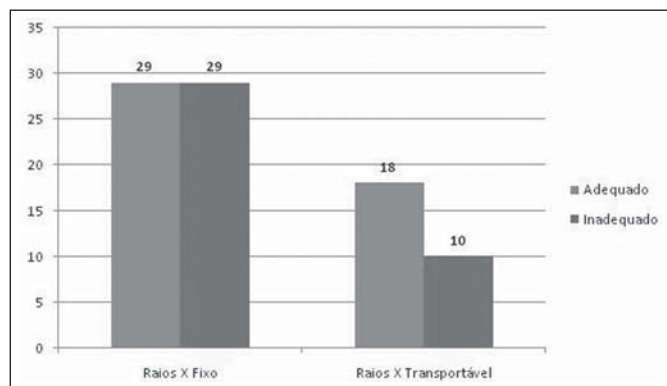
Among the 121 tested apparatuses, 32.23% ($n = 39$) presented problems regarding the collimation system accuracy and/or alignment of the X-ray beam central ray, most of those 39 apparatuses ($n = 22$) belonging to private centers. Among the tested apparatuses, 23.96% ($n = 29$) were classified as fixed X-ray apparatuses with problems, while 8.26% ($n = 10$) were portable apparatuses that were not compliant with the quality assurance standards.

Figure 5. Chart demonstrating the classification of the X-ray apparatuses into fixed and portable apparatuses, according to the results of the quality control tests performed in the Paraíba state in 2008.

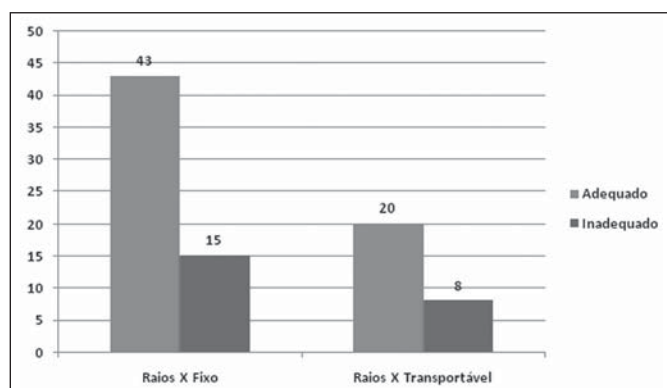
system accuracy and/or X-ray beam alignment, most of them ($n = 13$) belonging to private clinics. As regards the classification of the apparatuses, among all the apparatuses monitored in 2009, 12.82% ($n = 15$) were classified as fixed apparatuses with problems, and 6.83% ($n = 8$), as portable, non compliant apparatuses.

In the present study, 71.07% ($n = 86$) of the apparatuses tested in 2008 were tested again in 2009, with improvement in QCT results of 18.6% ($n = 16$) from one year to another (Figures 5 and 6). The other apparatuses tested in both years obtained the same satisfactory results on the collimation system accuracy and central ray

Figure 6. Chart demonstrating the classification of the X-ray apparatuses into fixed and portable apparatuses, according to the results of the quality control tests performed in the Paraíba state in 2009.
